# **Studsvik**

## ***Microstructural and Chemical Characterization of Irradiation Effects in Claddings with Different Alloy Compositions***

11th Conference on Reactor Material Science, 27-31 May  
2019

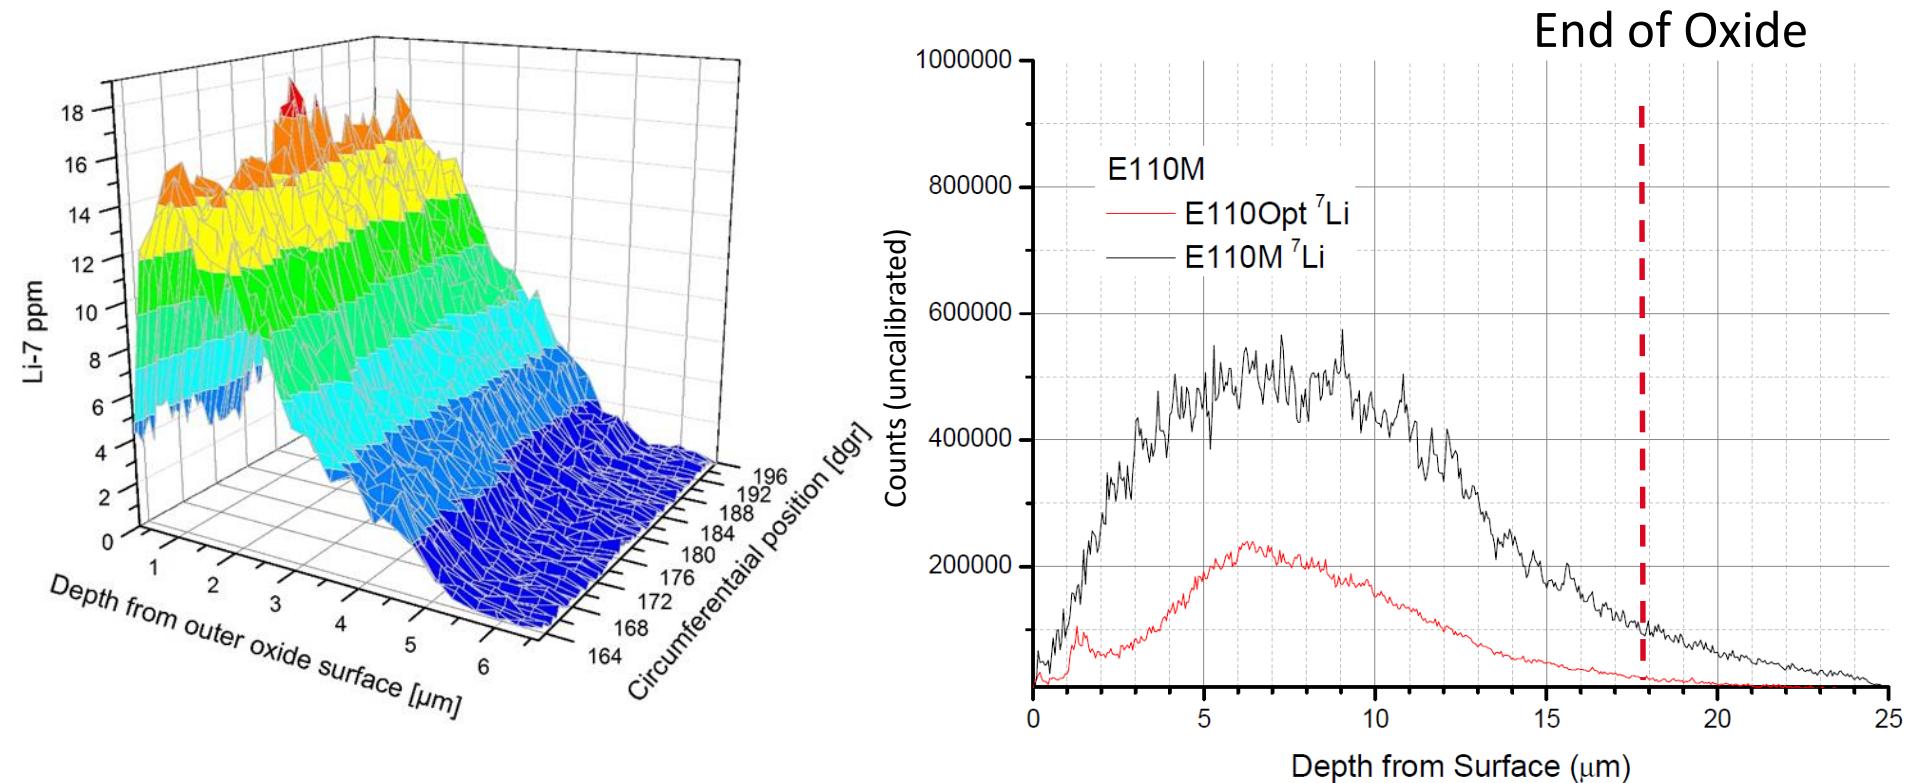
Typical results (left) from zry clads run in elevated lithium water chemistry in power reactors compared to preliminary results from E110M and E110-Opt run in very high Li in HBWR (right), indicating higher Li uptake in E110M

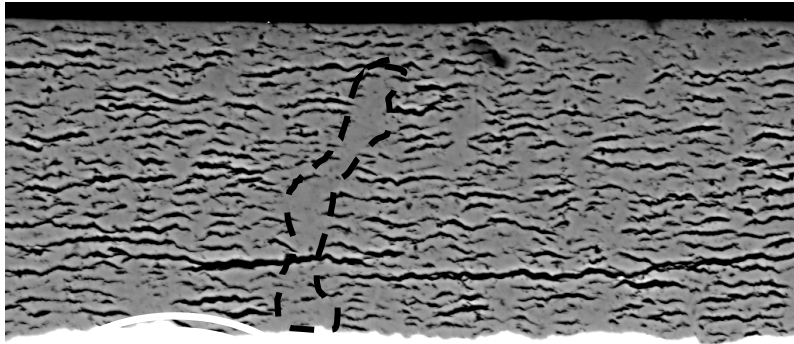
**SAMPLE  
E635M**

Dense “veins” in oxide layer

Circumferential crack pattern

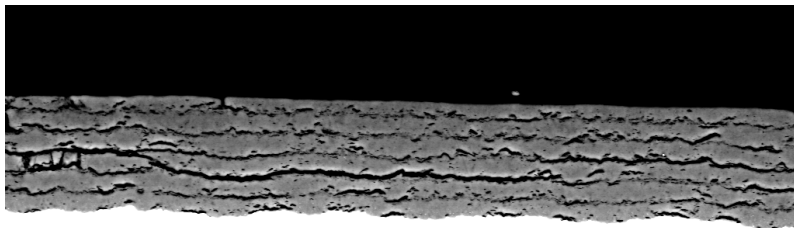
**SAMPLE  
E110OPT**

Circumferential crack pattern  
Some radial cracking observed  
Higher density of small pores

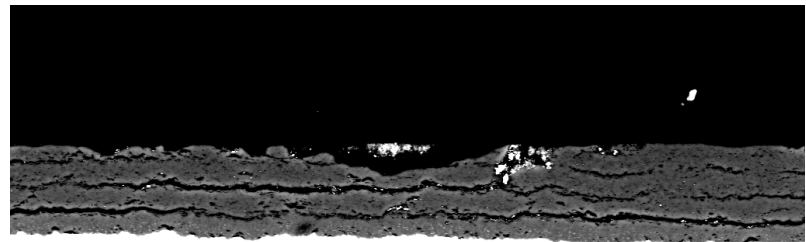
**SAMPLE  
E125**

Circumferential crack pattern  
Highest density of small pores

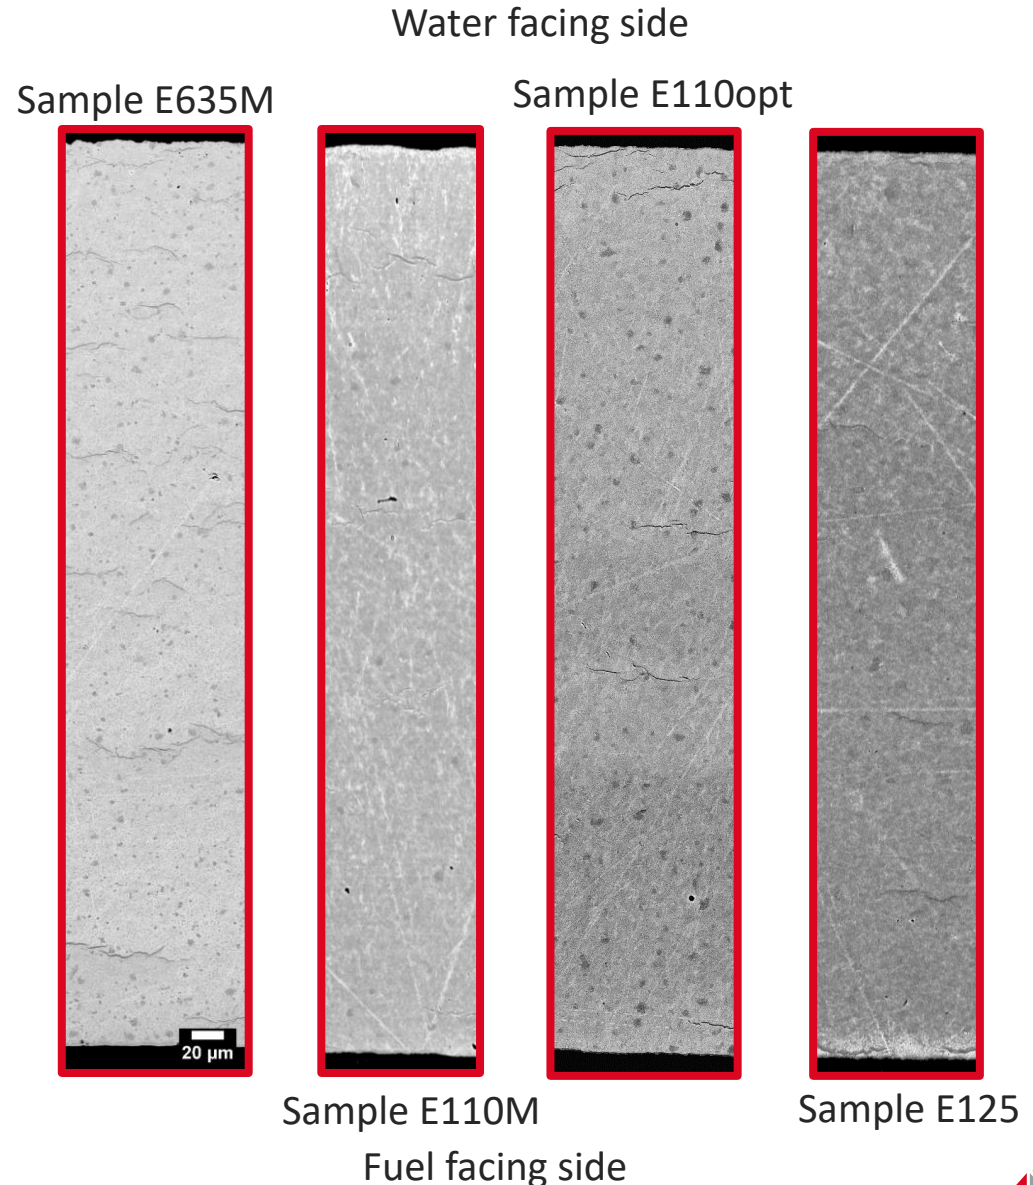
- Hydrides evenly distributed throughout the cladding – no rim formation at these low hydrogen concentrations
- More hydrogen in the E635M alloy correlating well to the thicker oxide layer
- Very low hydrogen concentrations in the other alloys

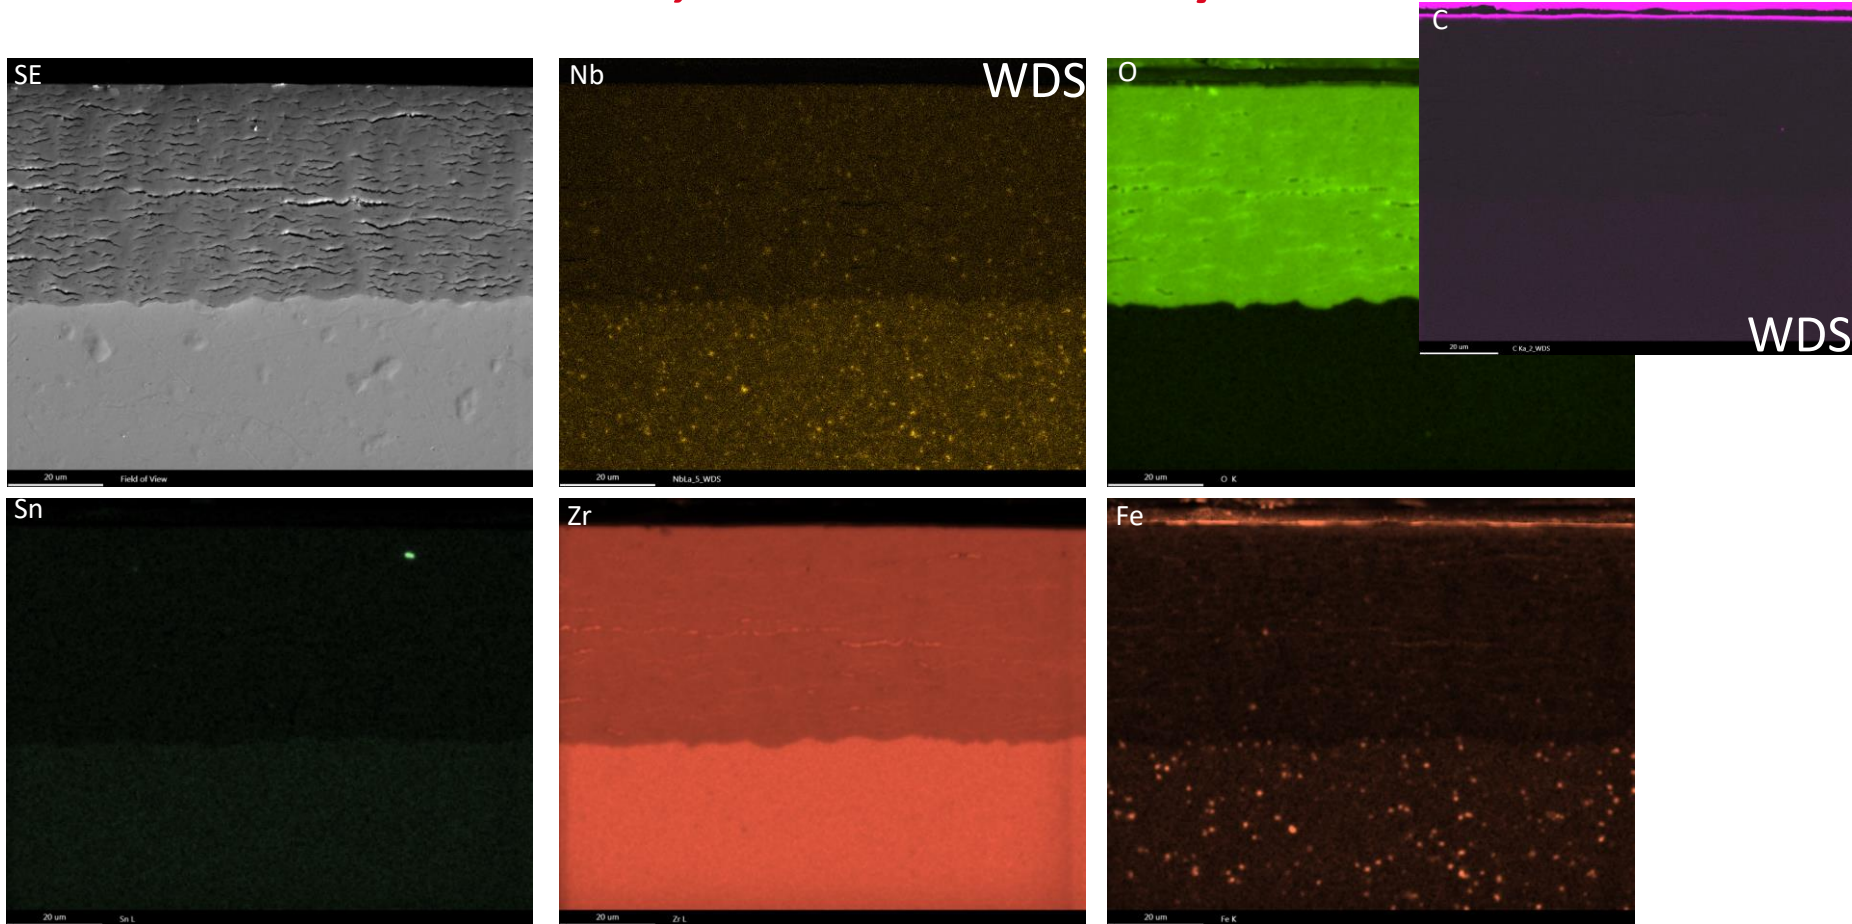
# SAMPLE E635M – NB, SN & HIGH FE – E/WDS MAPPING

- Relatively large particles in this material easily detected using EDS and WDS
- No major loss of Fe to the matrix phase can be observed from these data (as is usually observed on similar materials). Most particles seem to have Zr-Nb-Fe compositions
- Interestingly, particles seem to dissolve in the oxide. The further out in the oxide the fewer and faint particles. In the outer oxide no particles can be observed.

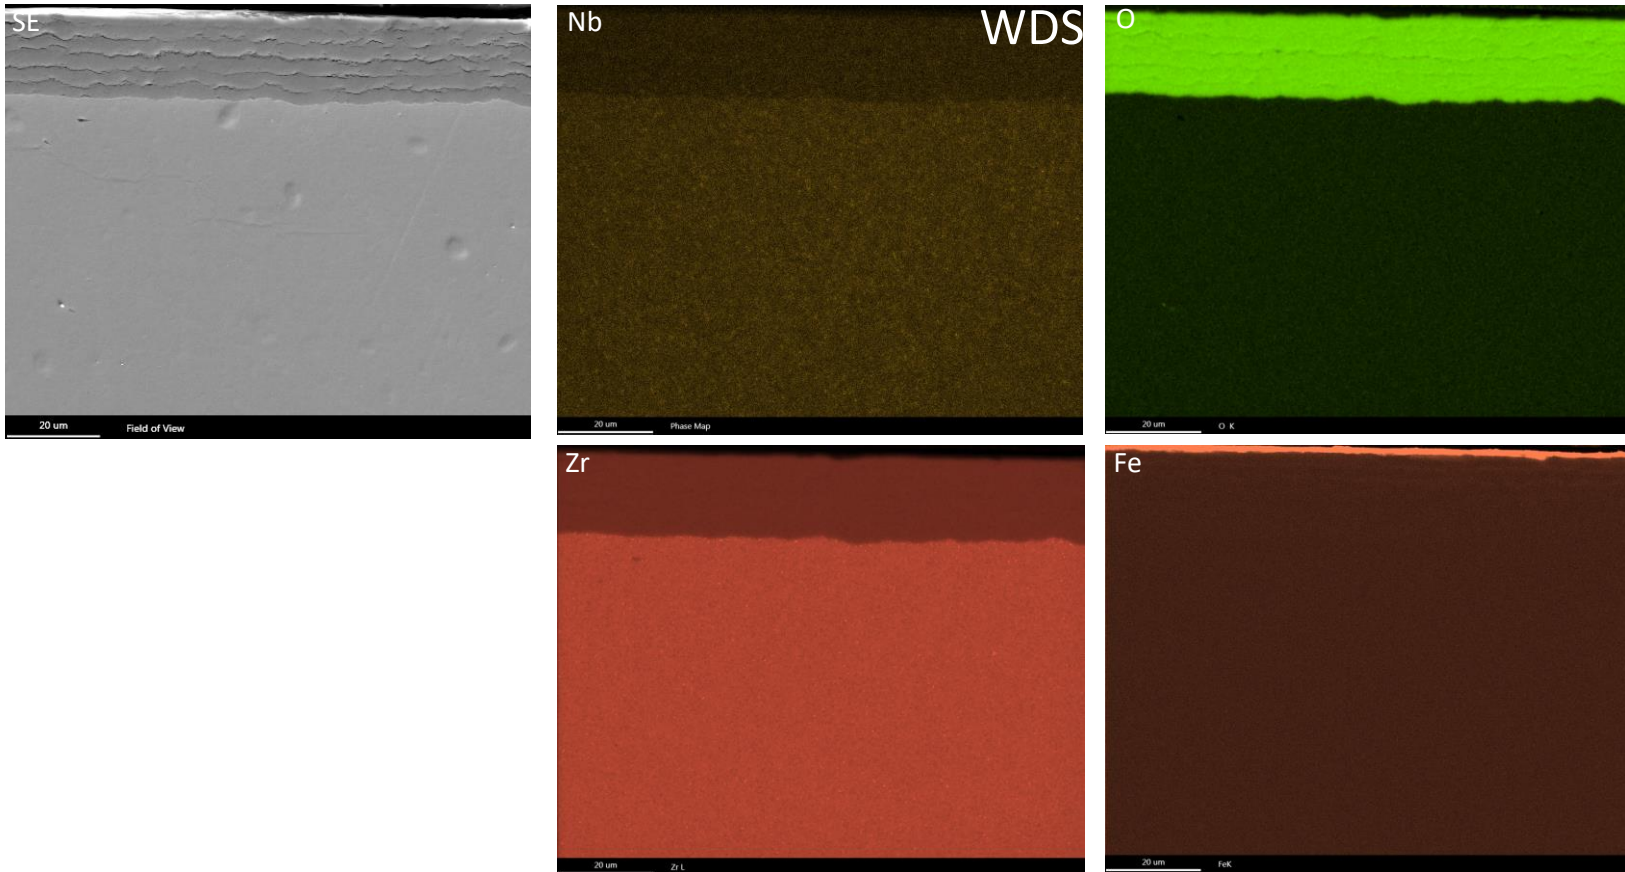
# SAMPLE E110M – NB & "HIGH" FE – E/WDS MAPPING

- Mottled appearance in Nb map indicated the presence of SPPs but too small to be detected individually using SEM/EDS/WDS

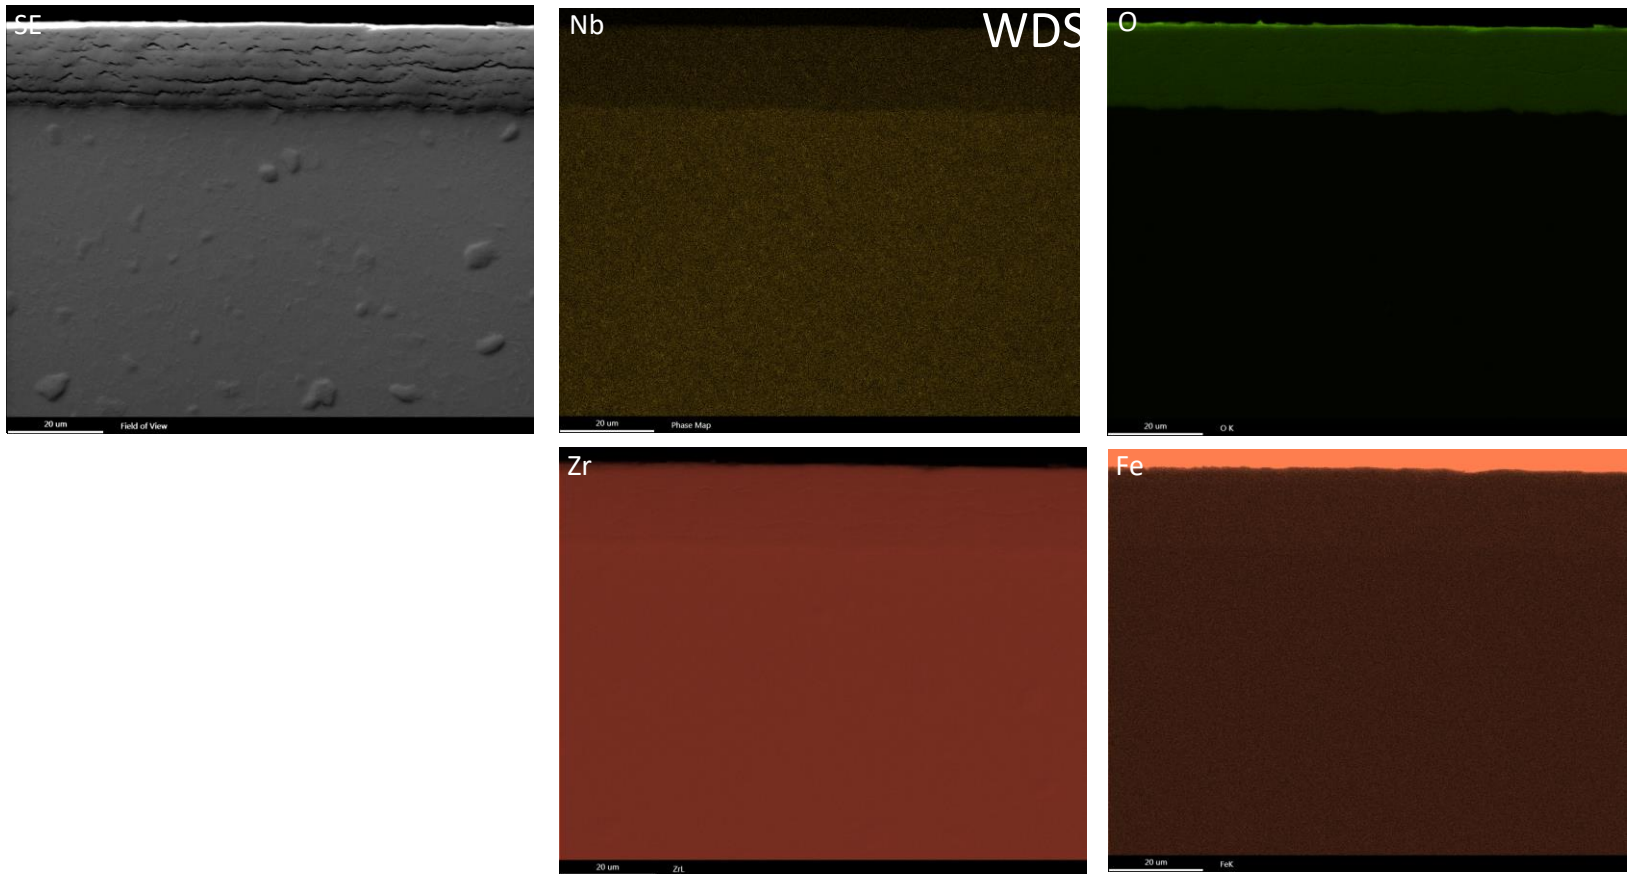
# SAMPLE E110OPT – NB & "LOW" FE – E/WDS MAPPING

- No SPPs or other variations in elemental composition could be observed

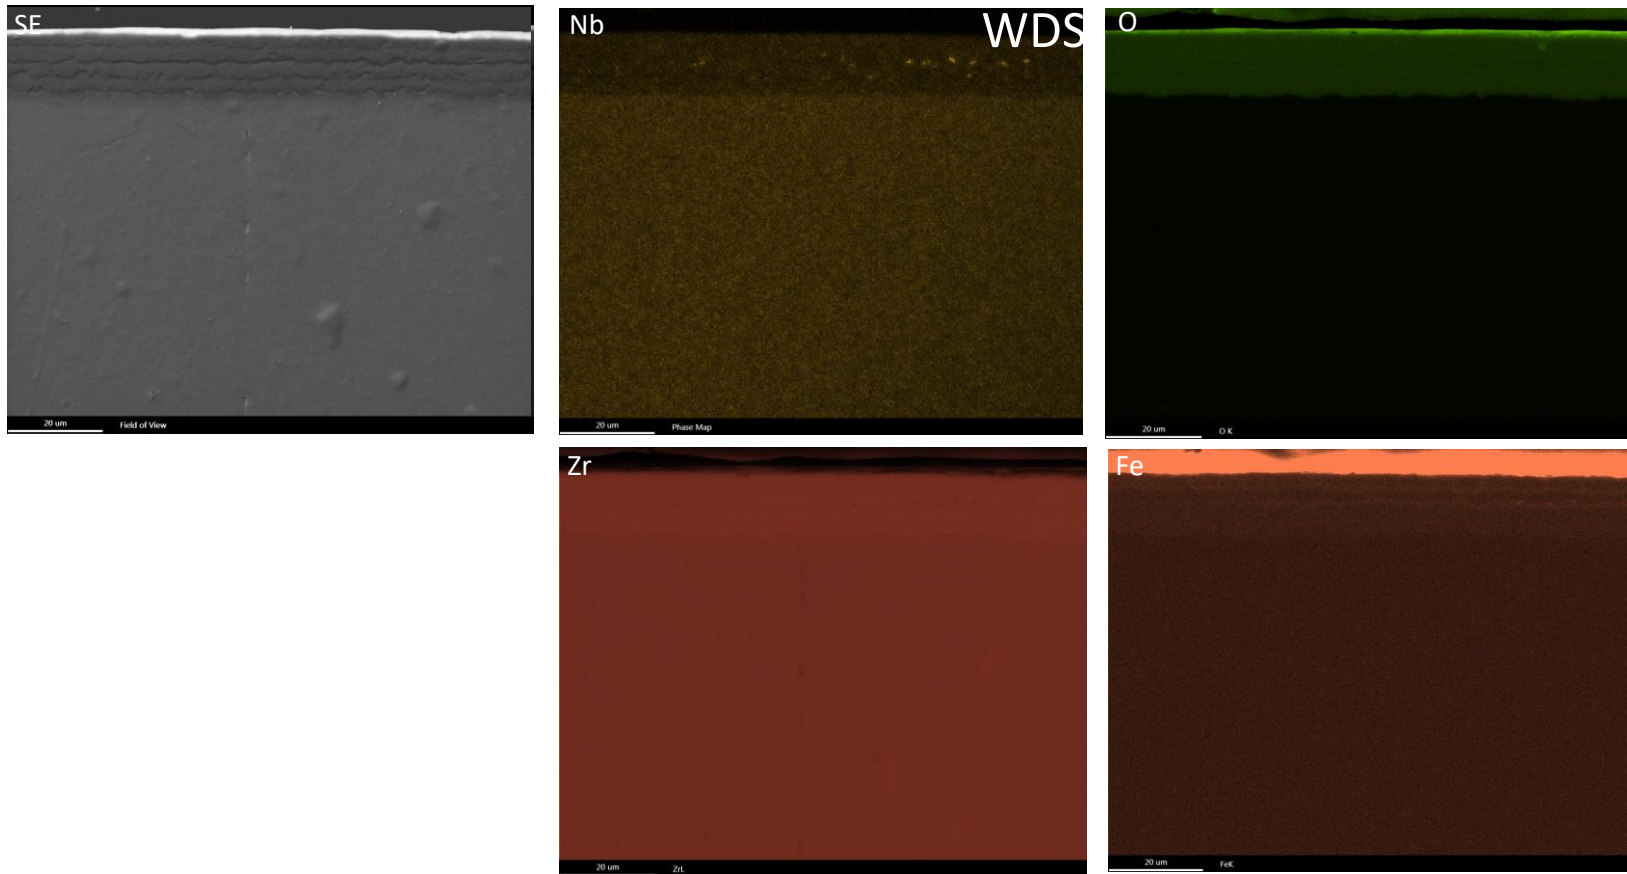
# ***SAMPLE E125 – HIGH NB AND “LOW” FE – E/WDS MAPPING***

- Nb (and Fe) enrichment in the oxide layer – possible precipitation in oxide?

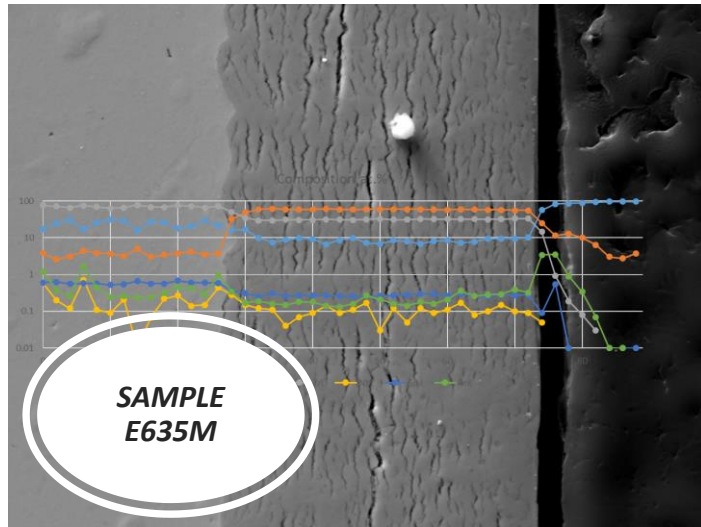
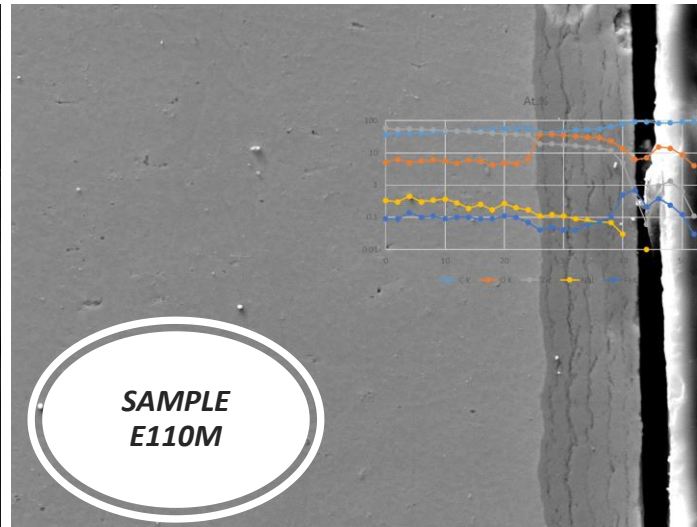
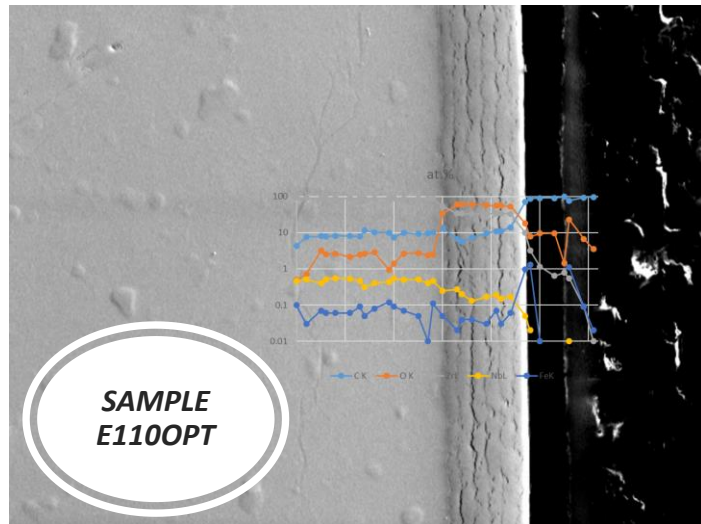
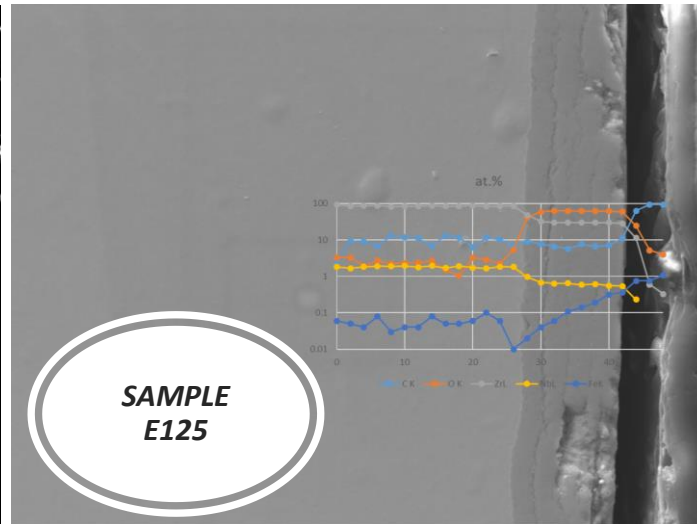
- Oxides homogenous regarding elemental composition in agreement with expected values
- No impurities or contaminants observed
- Possibly the Fe content increase towards the outer part of the oxide – observed for E110M, E110Opt and E125, not as obvious for E635M

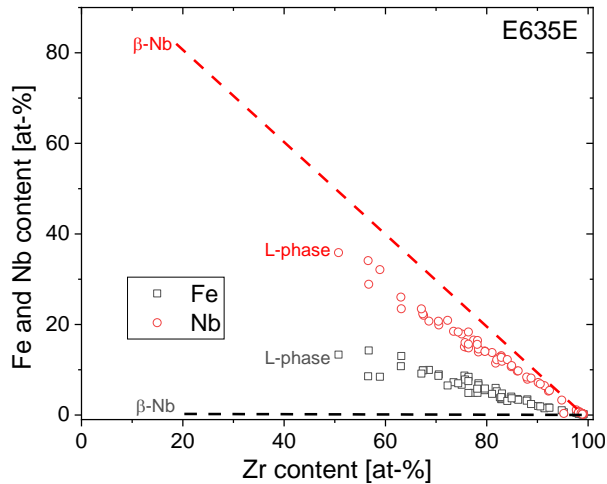
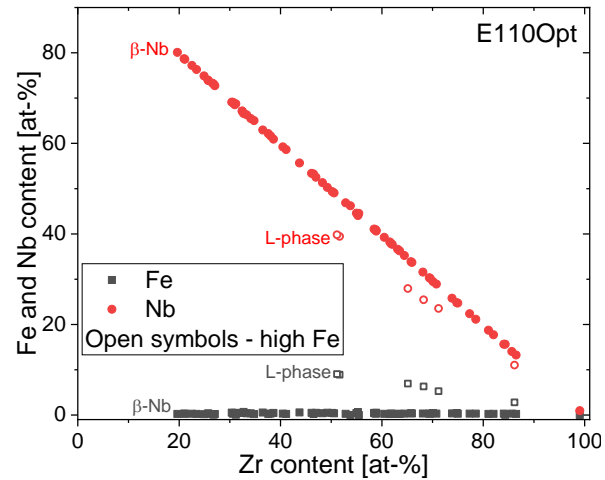
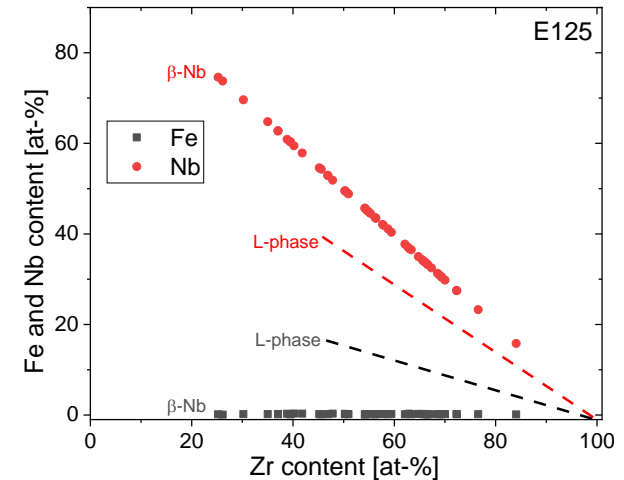
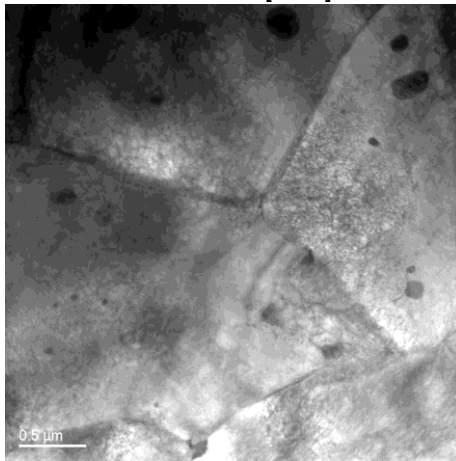
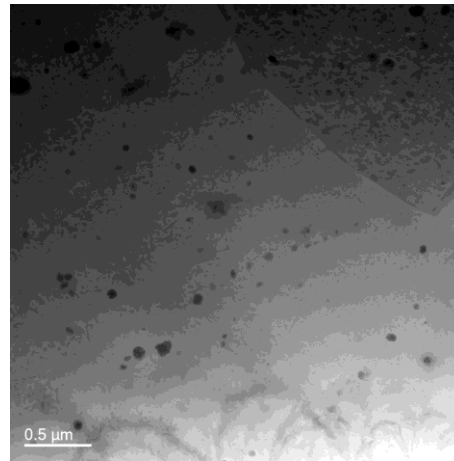
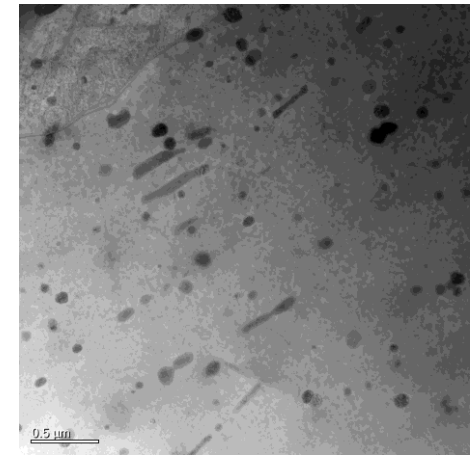
- The three alloys have a different set of SPPs after irradiation
- Supports the fact that the Laves phase particles dissolve during irradiation

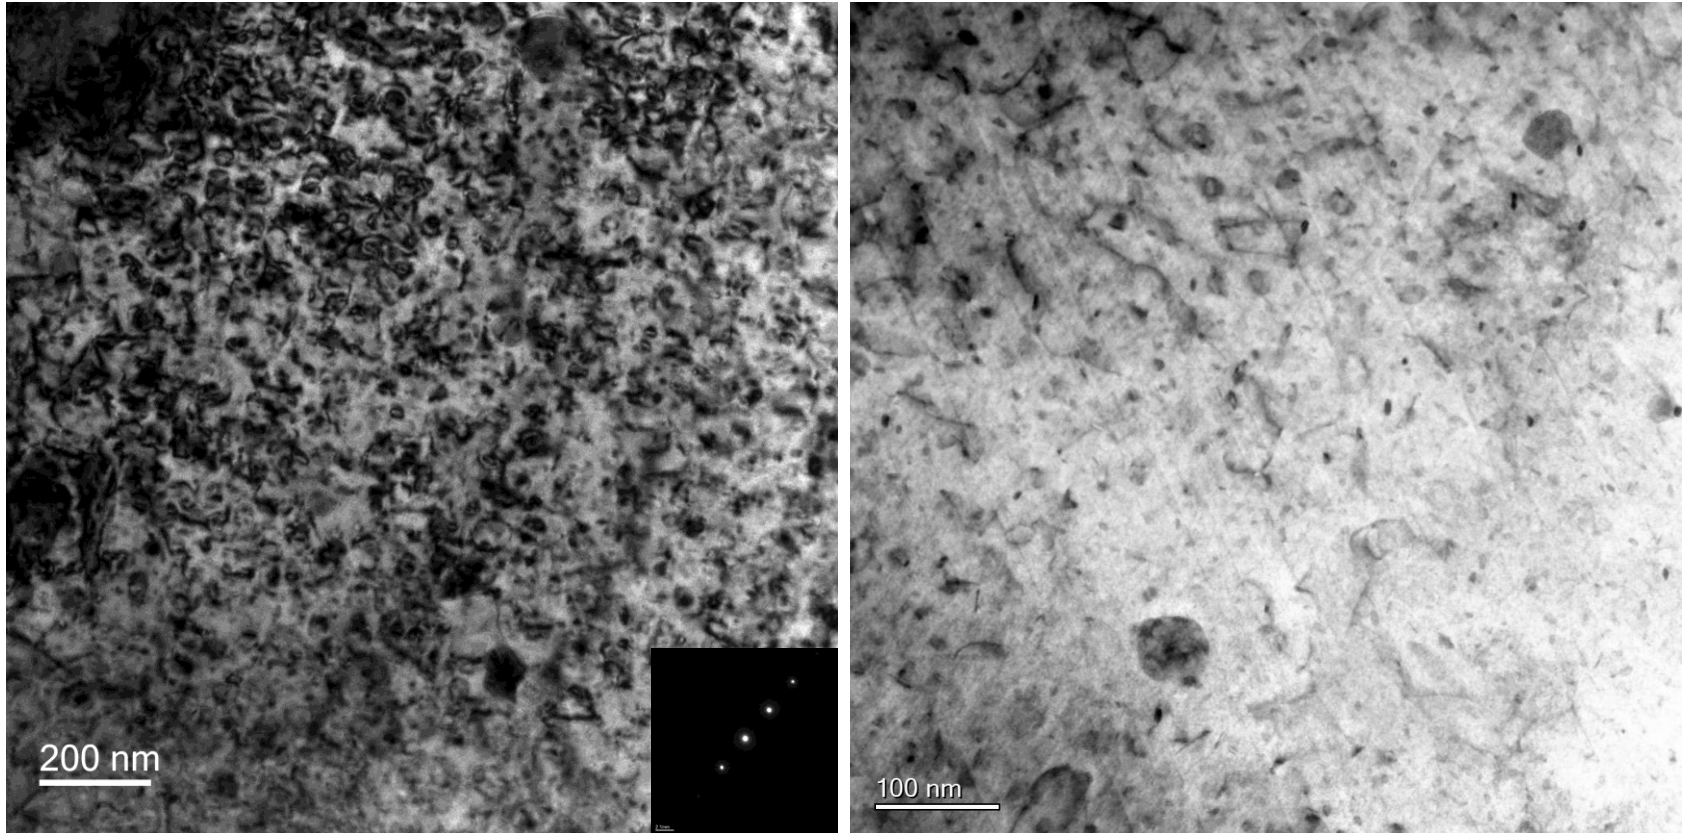
- A very high density of  $\langle a \rangle$ -component loops present in all material
- Still under evaluation regarding density and comparison between different alloys.

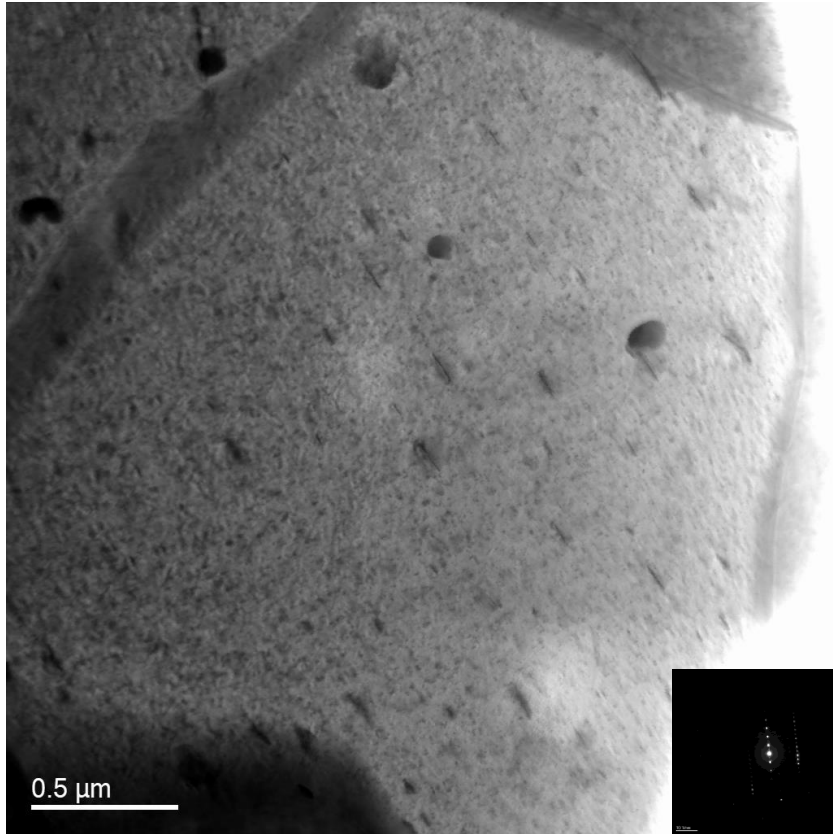
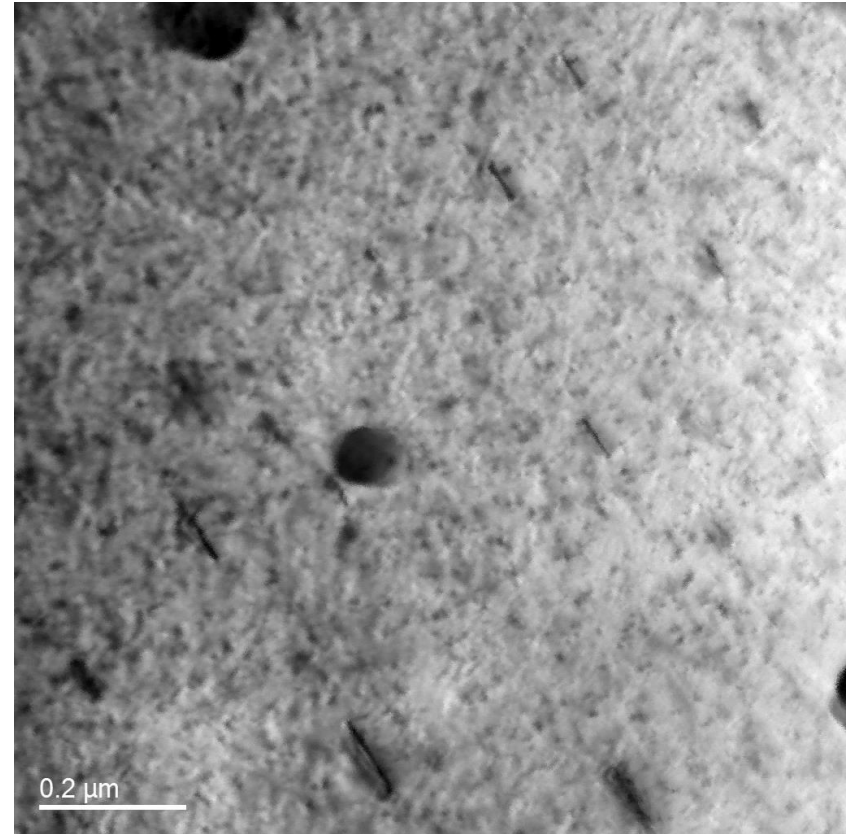
- A low density of  $\langle c \rangle$ -component loops present. Possibly the slightly higher than normal irradiation temperature affects the onset of  $\langle c \rangle$ -loop formation...?
- Still under evaluation regarding density and comparison between different alloys.
