# **Studsvik**

## ***Microstructural and Chemical Characterization of Irradiation Effects in Claddings with Different Alloy Compositions***

11th Conference on Reactor Material Science, 27-31 May  
2019

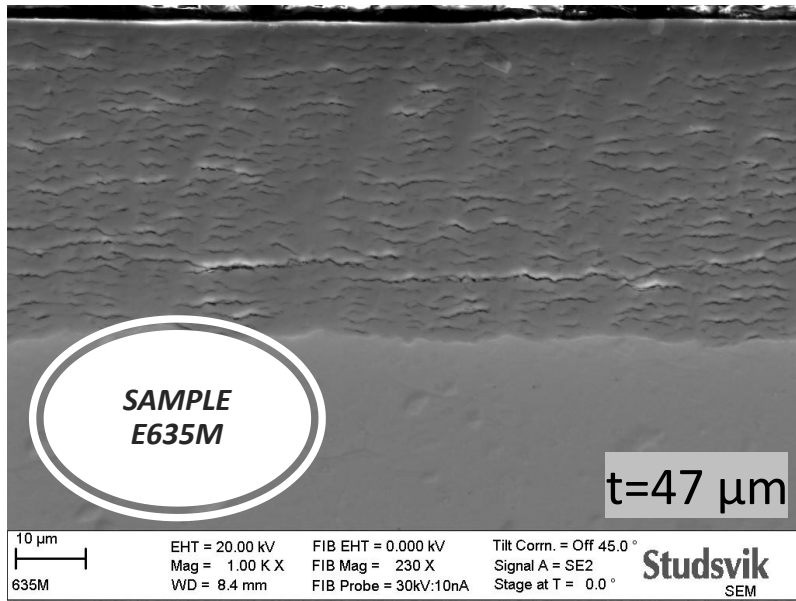
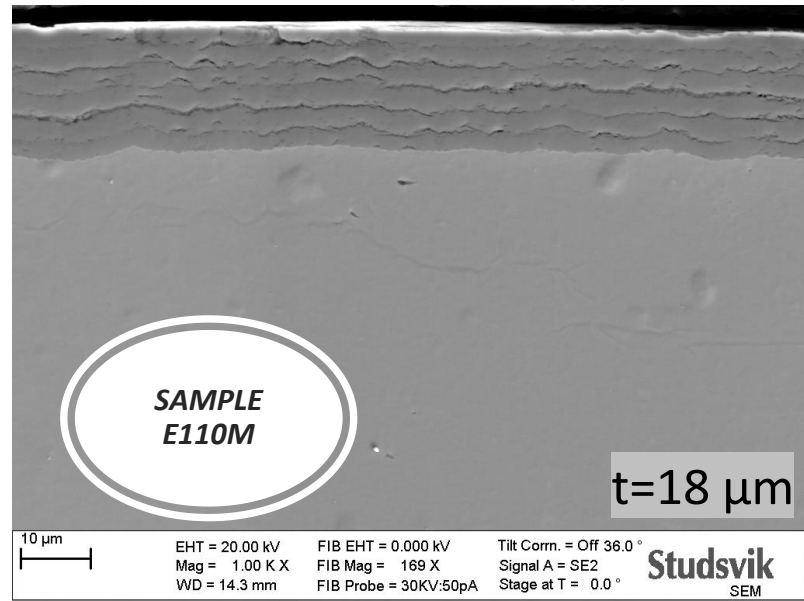
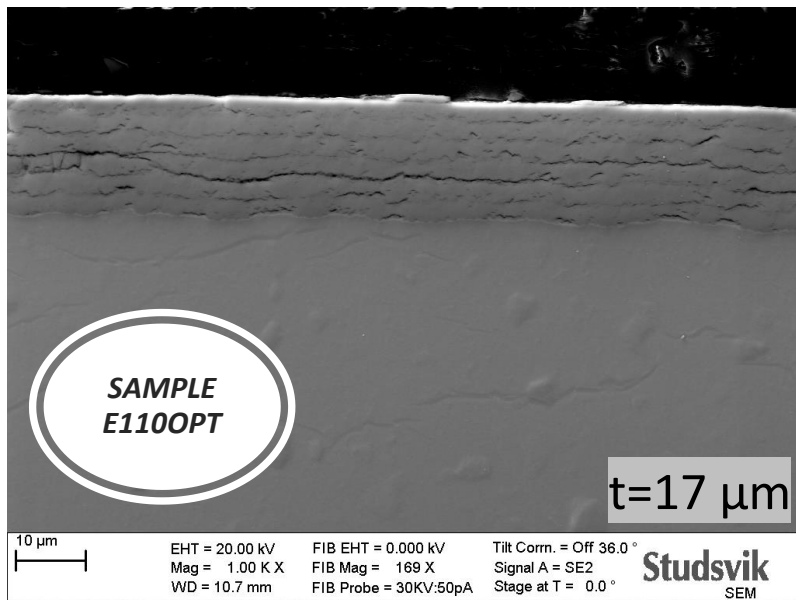
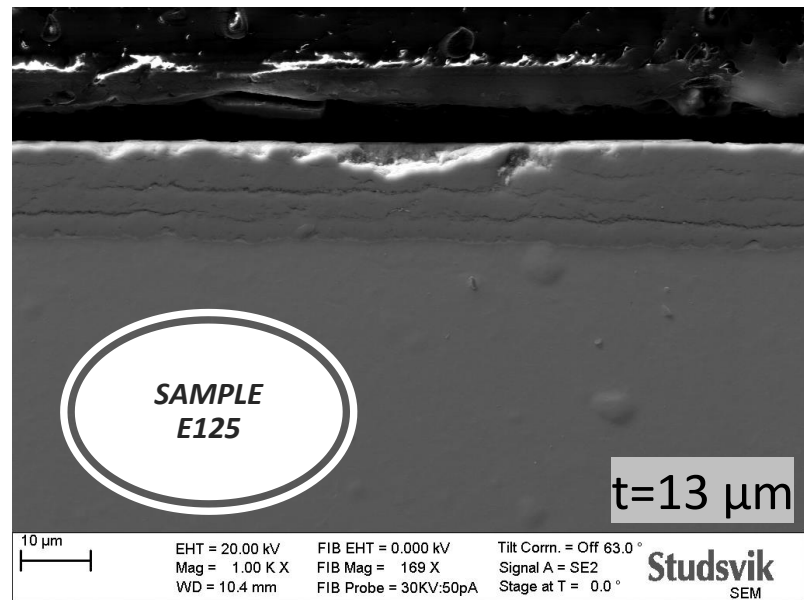
# OXIDE THICKNESS AND MORPHOLOGY (1)

- SEM shows that alloy E635M corrodes the most in reactor
- The oxide morphology is different depending on alloy composition. More small pores are present in the high Nb alloy E125.
- Dissolution of particles seems to take place in the oxide layer. The oxide layer for Alloy E635M show clear SPPs in the inner of the oxide but none in the outer parts
- Nb rich precipitates have formed in the high Nb alloy E125 oxide layer
- Fe levels higher in the outer part of the oxide layers indicate possible uptake from external sources.
